DEPARTMENT OF TRANSPORTATION

Quality Assurance and Source Inspection

Contract #: 04-0120F4Cty: SF/ALA Rte: 80 PM: 13.2/13.9File #: 69.28**WELDING INSPECTION REPORT****Resident Engineer:**Siegenthaler, Peter**Address:** 333 Burma Road**City:** Oakland, CA 94607**Report No:** WIR-025649**Date Inspected:** 27-Jul-2011**Project Name:** SAS Superstructure**OSM Arrival Time:** 1900**Prime Contractor:** American Bridge/Fluor Enterprises, a JV**OSM Departure Time:** 700**Contractor:** Zhenhua Port Machinery Company, Ltd (ZPMC), Changxing Island **Location:** Shanghai, China**CWI Name:** N/A**CWI Present:** Yes No**Inspected CWI report:** Yes No N/A**Rod Oven in Use:** Yes No N/A**Electrode to specification:** Yes No N/A**Weld Procedures Followed:** Yes No N/A**Qualified Welders:** Yes No N/A**Verified Joint Fit-up:** Yes No N/A**Approved Drawings:** Yes No N/A**Approved WPS:** Yes No N/A**Delayed / Cancelled:** Yes No N/A**Bridge No:** 34-0006**Component:** OBG**Summary of Items Observed:**

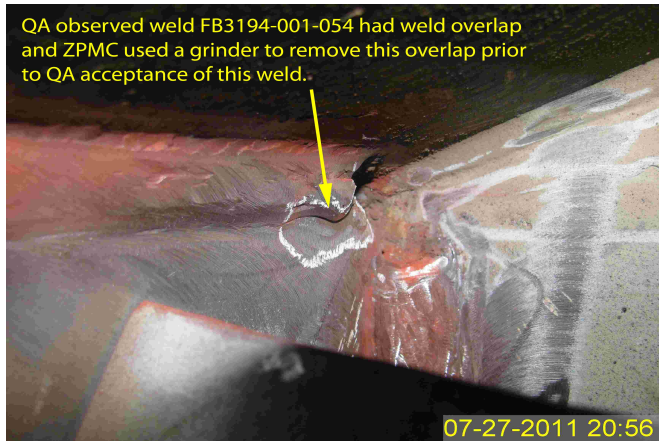
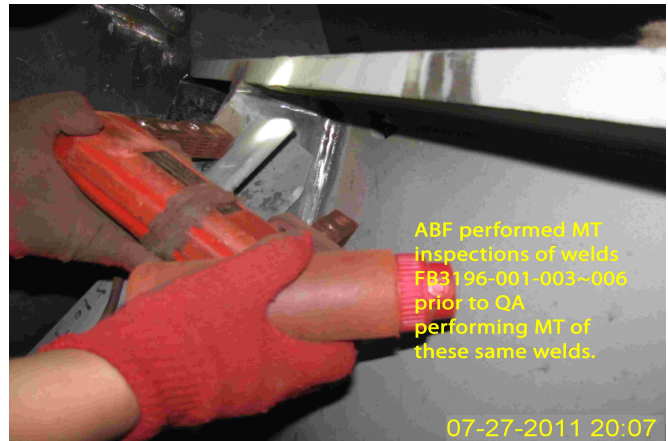
Caltrans and ABF have agreed to conduct visual and magnetic particle inspections (MT) of segment 13 West welds as part of a special inspection program reference NWIT 9822. This QA Inspector observed ABF Inspectors had completed and accepted MT inspections of welds: FB3194-001-053, 054, 055; FB3196-001-003, 004, 005, 006, 007, 008, 009, 010, 017, 018, 019 and 020. This QA Inspector performed random visual and magnetic particle inspection of welds: FB3194-001-053, 054, 055; FB3196-001-003, 004, 005, 006, 007, 008, 009, 010, 017, 018, 019, 020 and these welds appear to comply with AWS D1.5 MT and visual requirements. For additional information on these inspections see this QA Inspector's TL6028 Magnetic Particle Test Report and the photograph below.
